Draft Final Report • National Institute of Standards and Technology (NIST)

of the May 22, 2011,
Tornado in
Joplin, Missouri

NIST NCSTAR 3 (Draft)

November 2013

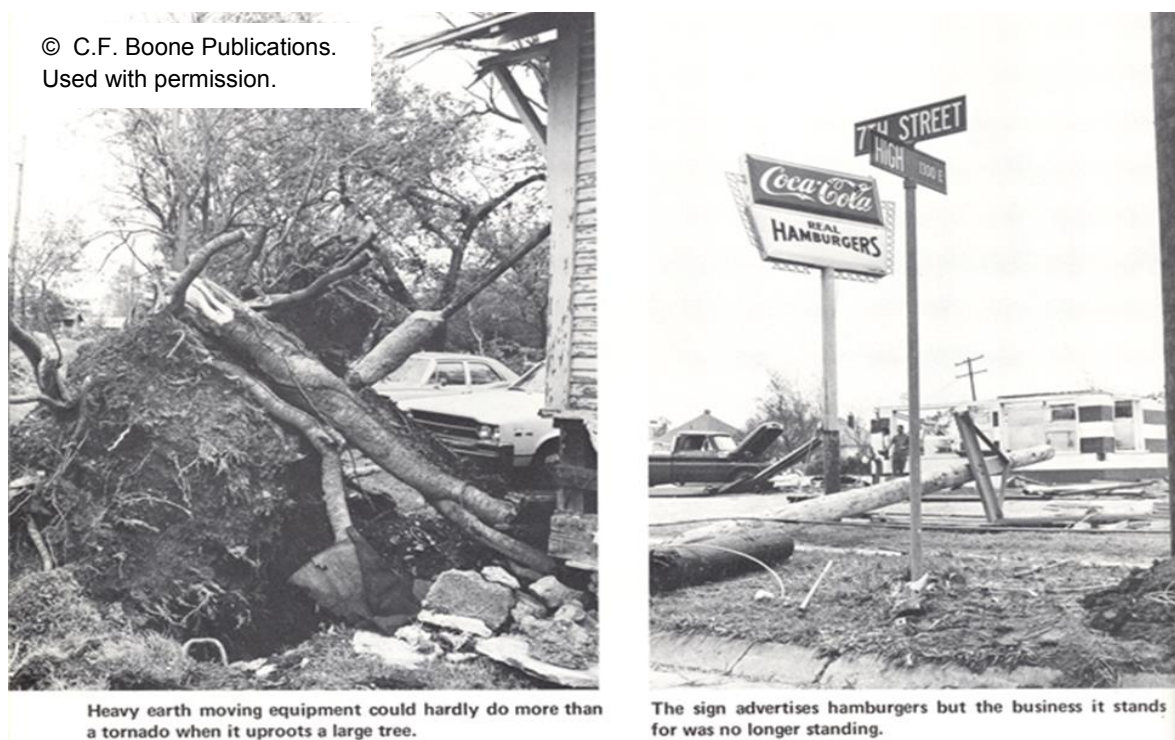
Figure 1–3. Damage from the 1971 Joplin tornado.³¹

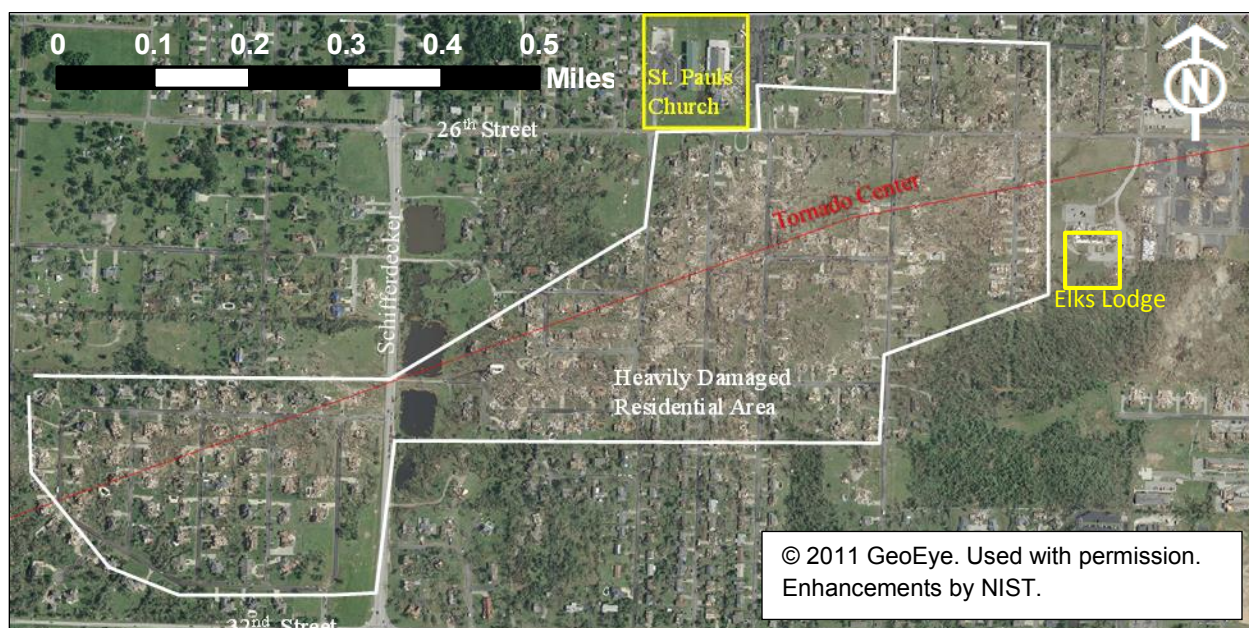
Figure 1–5. Damage on the west side of Joplin.

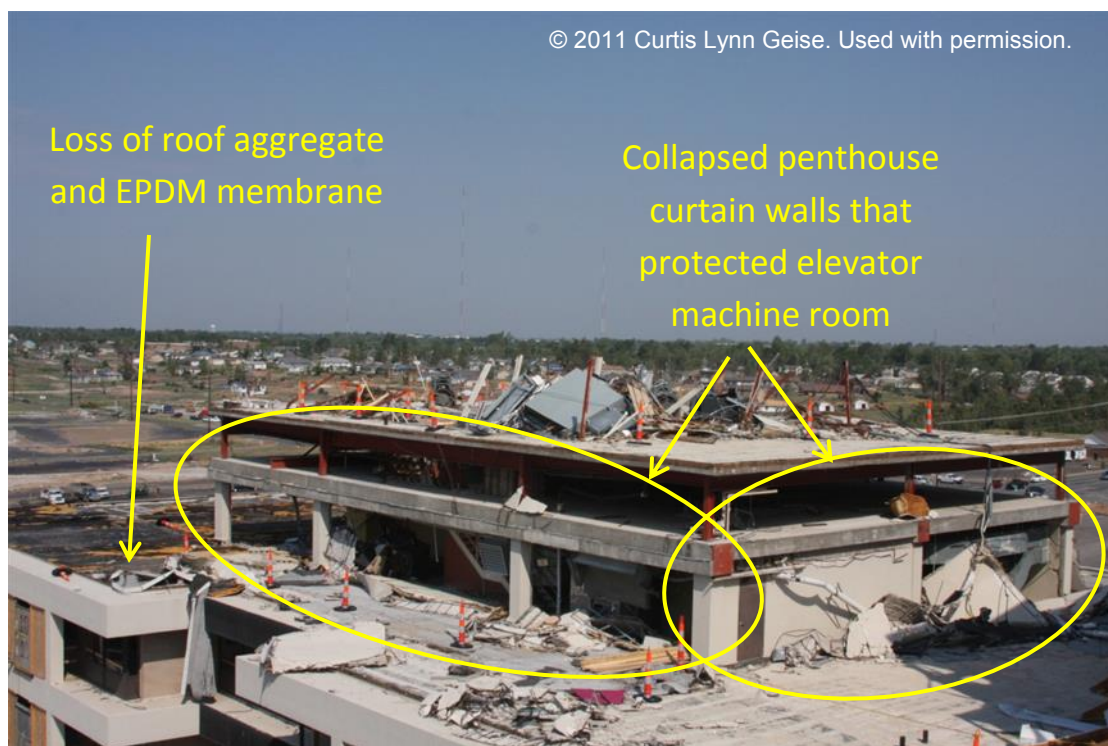
Figure 3–12. Damage to roof and penthouse walls of West Tower.

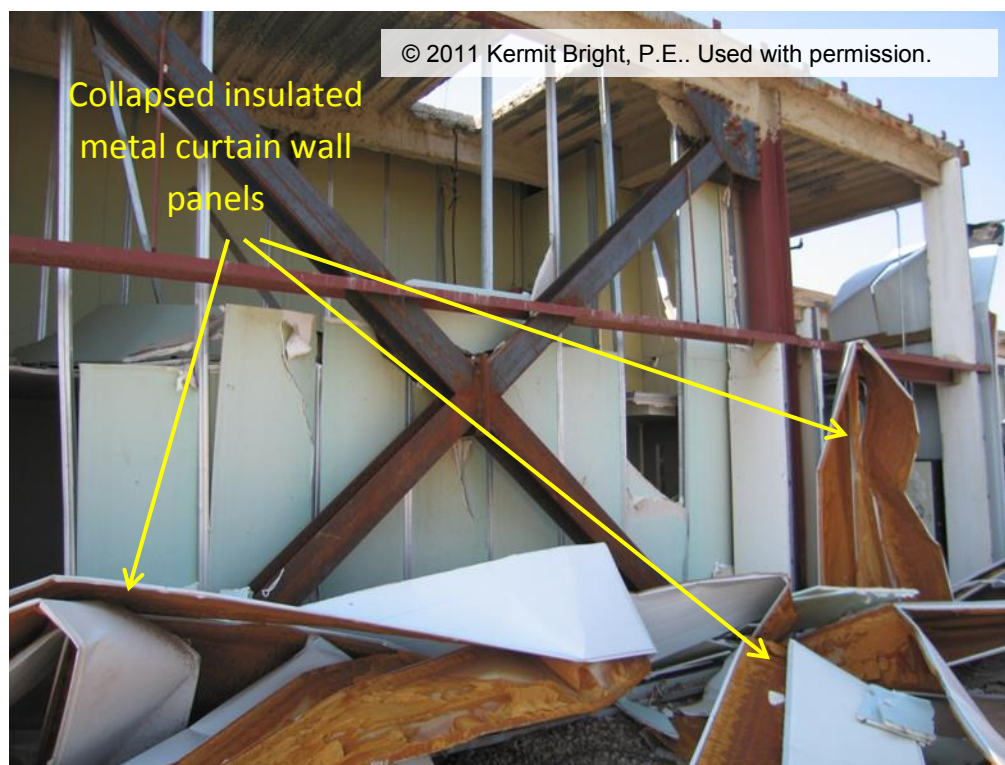
Figure 3–17. Missing/collapsed vertical insulated metal curtain wall panels of East Tower penthouse.

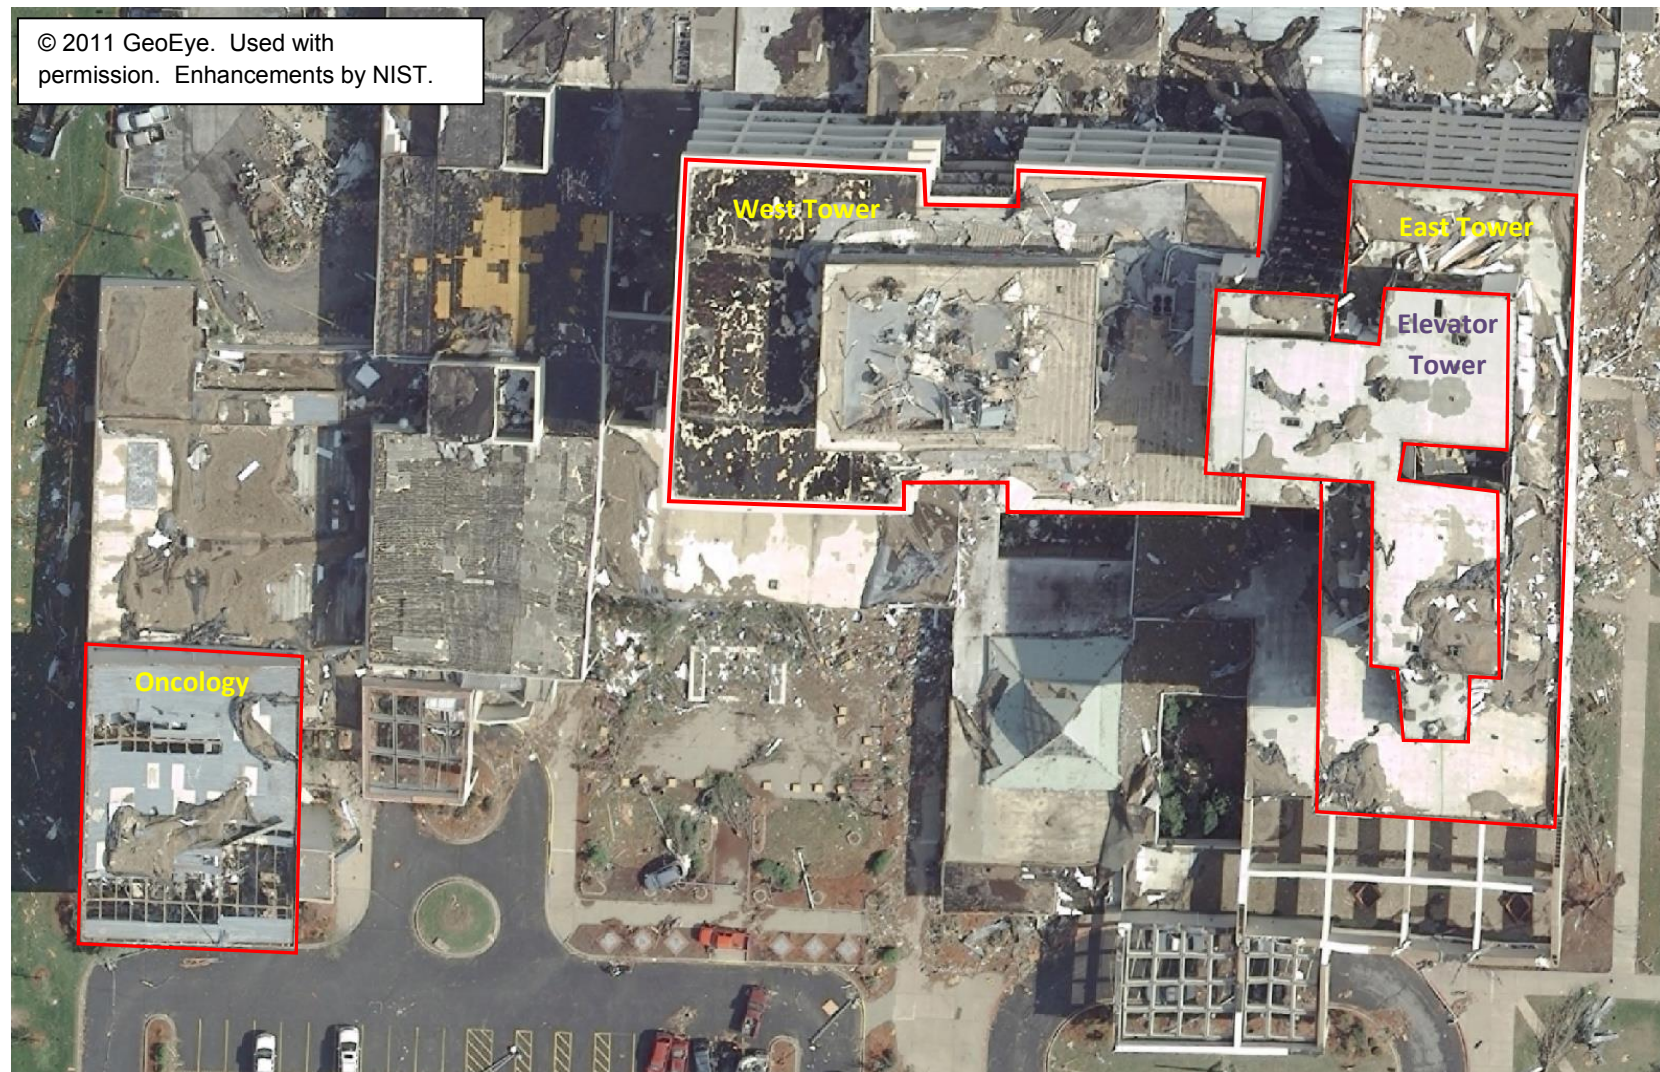
Figure 3–19. Overview of West, East, and Elevator Towers and Oncology Clinic Building showing that most of the aggregates that were used as roof ballast on these buildings are missing.

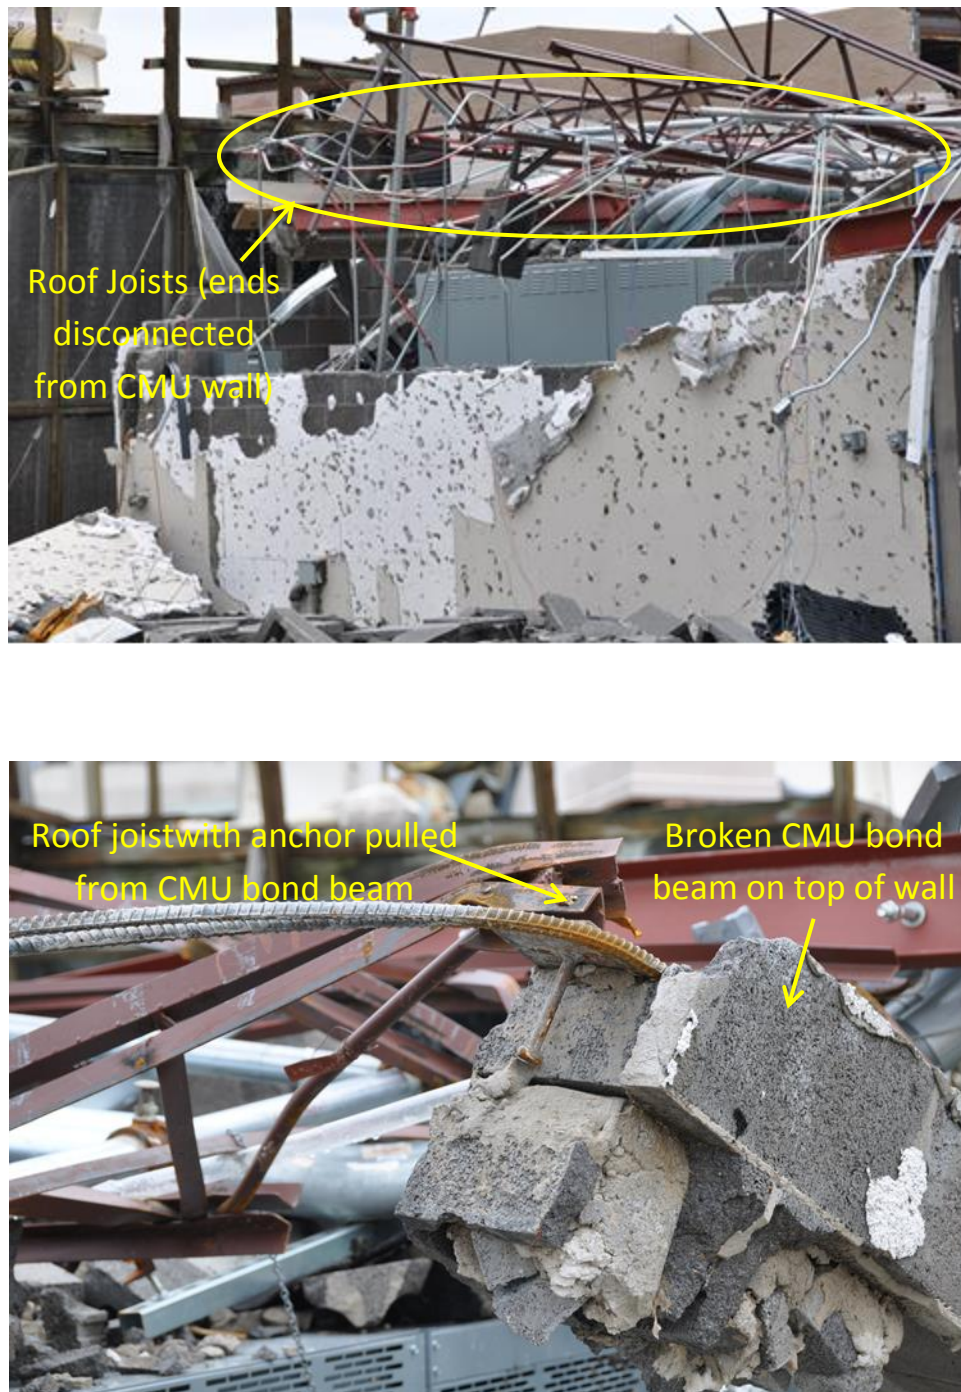
Figure 3–22. Failure details at Emergency Generator Building.

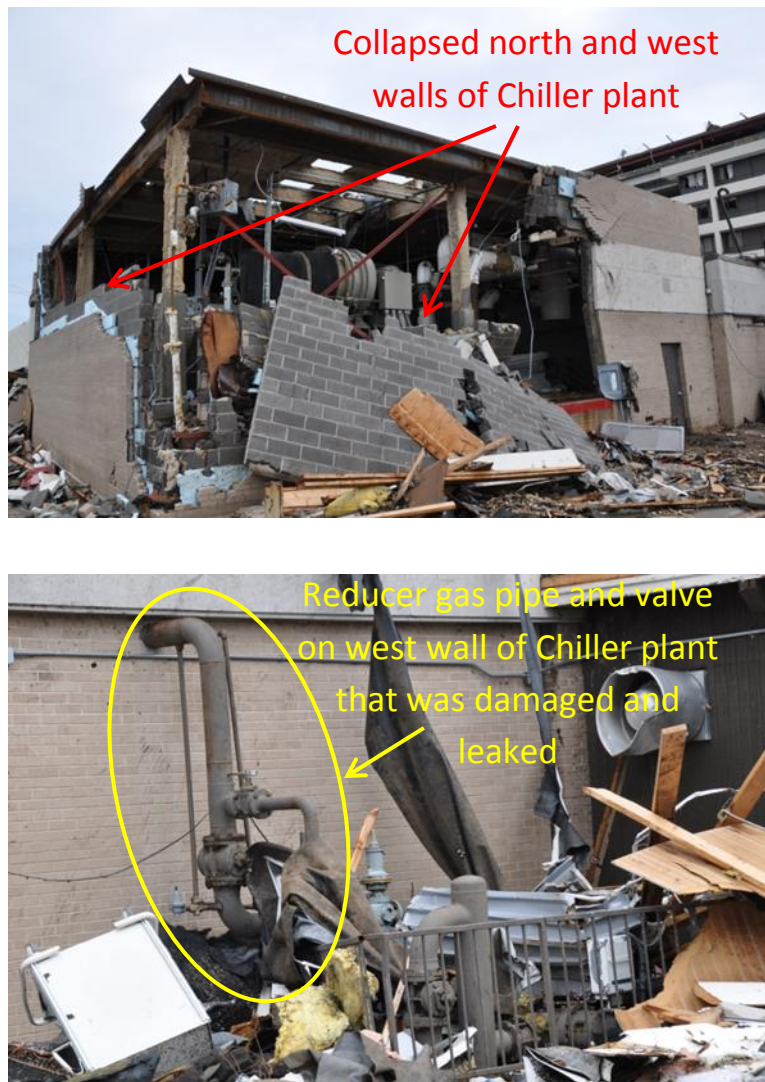
Figure 3–23. Views of damage sustained at the Chiller Plant.

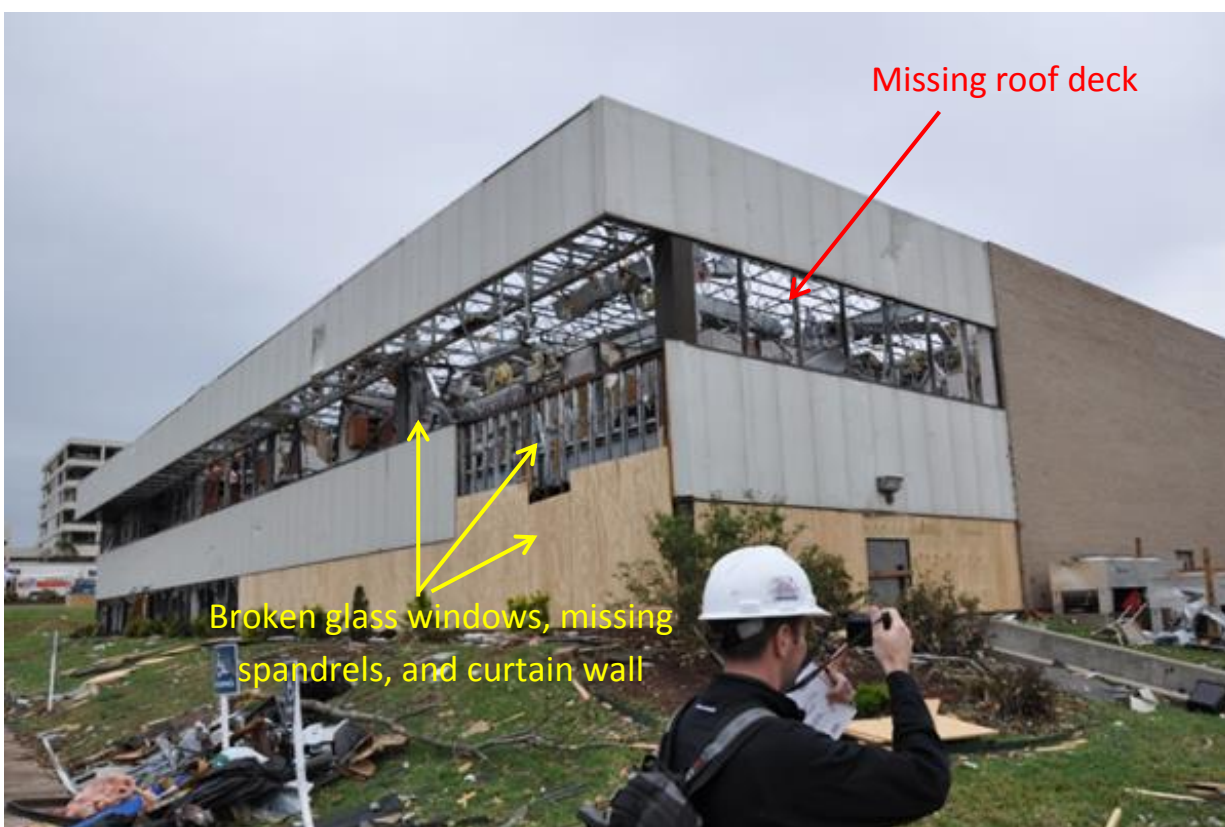
Figure 3–28. View of damage to envelope of Medical Office Building 1.

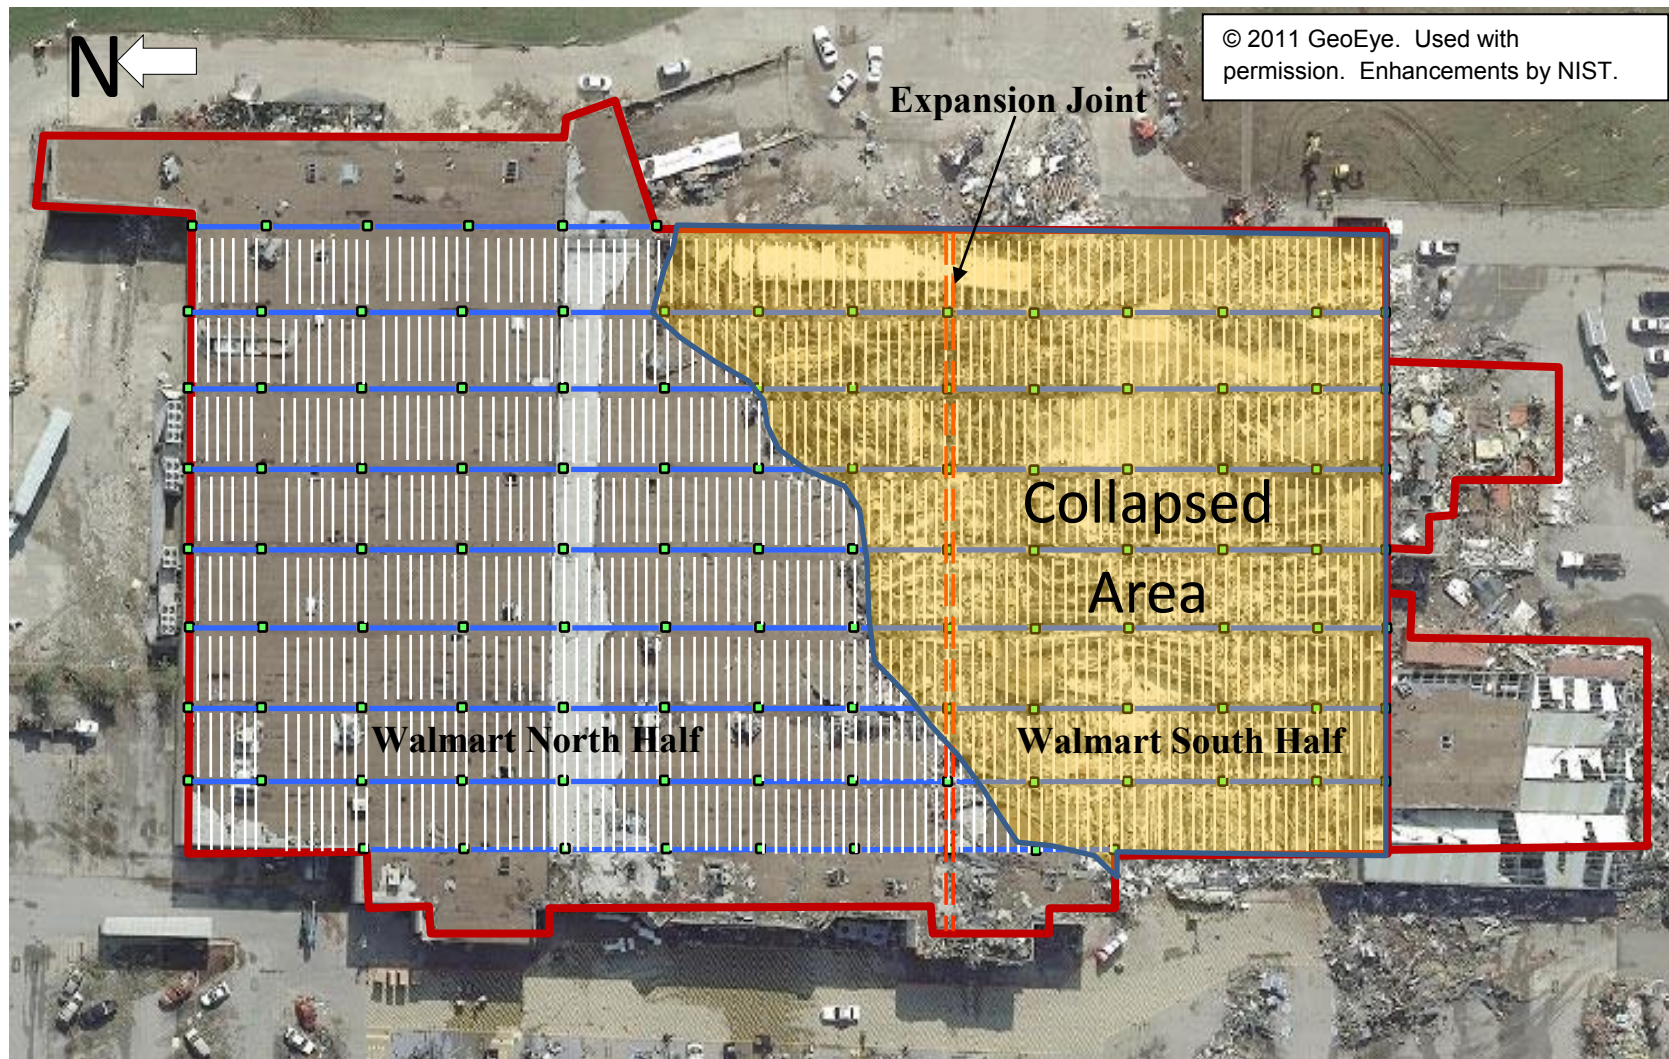
Figure 3–34. Aerial view of Walmart outlining southern half of building collapsed by the tornado.

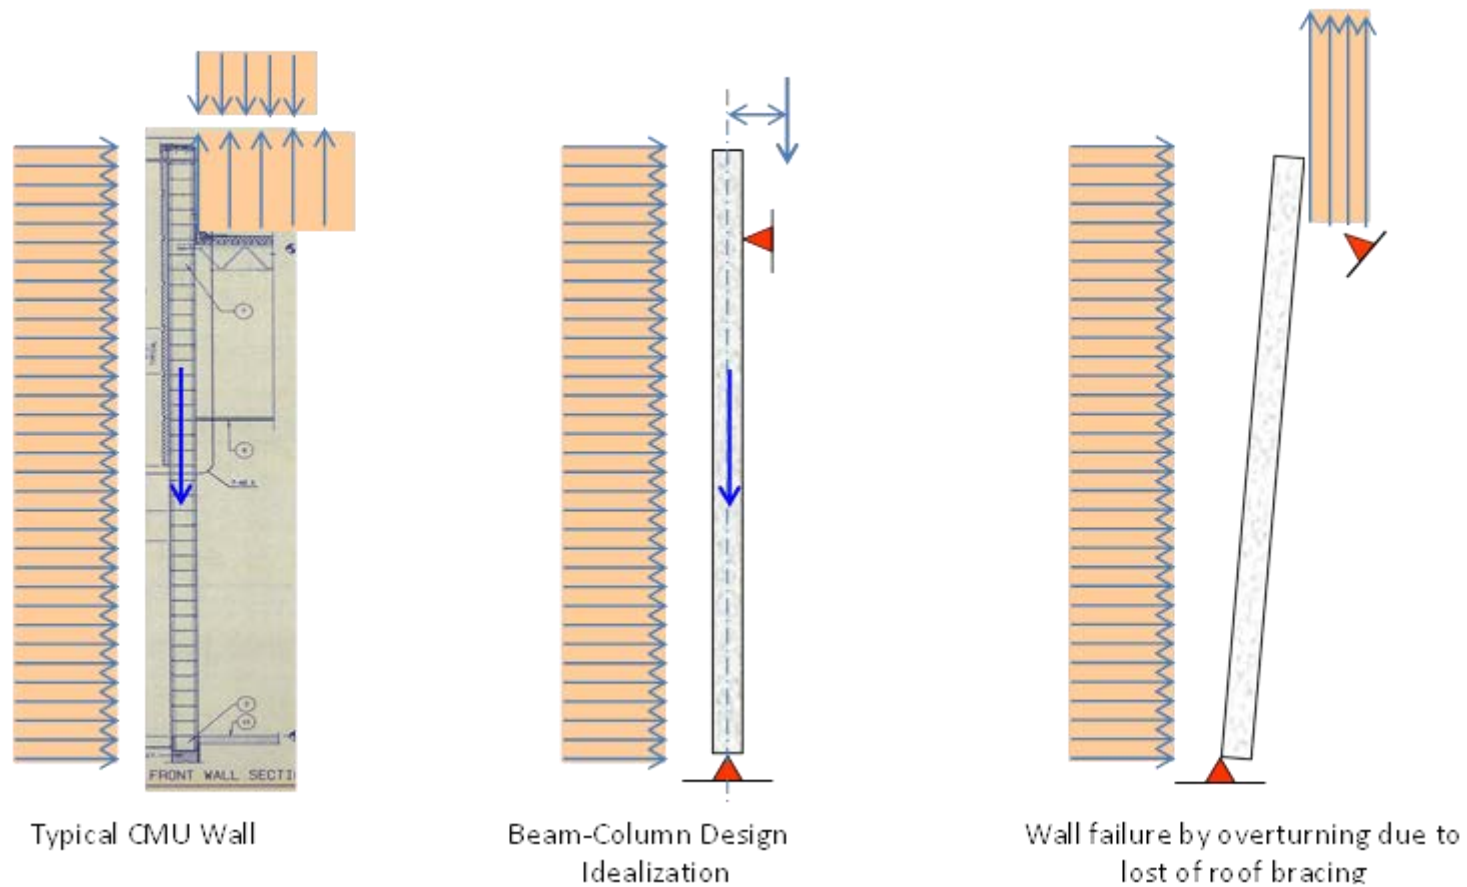
Figure 3–41. Typical loading and design conditions for BTS building and possible failure mode.

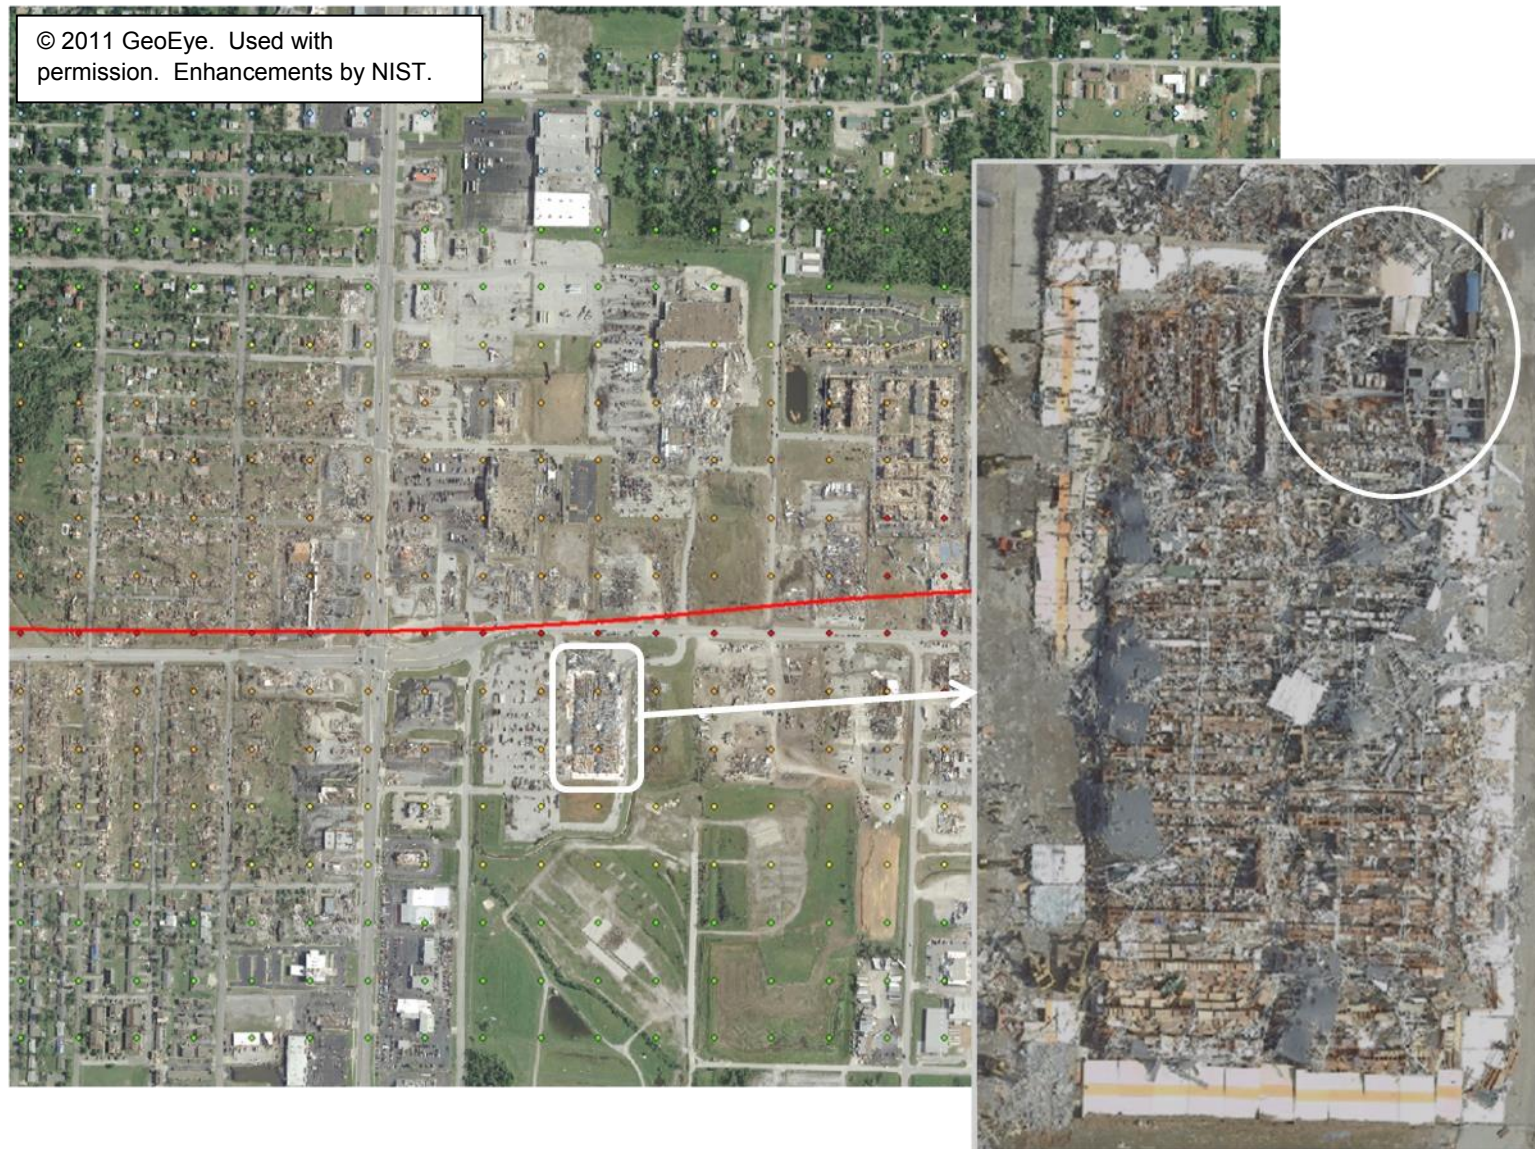
Figure 3–42. Aerial views of Home Depot in relation to the tornado damage path (red line denotes center of damage path). Note the loss of all roof decks due to wind uplift.

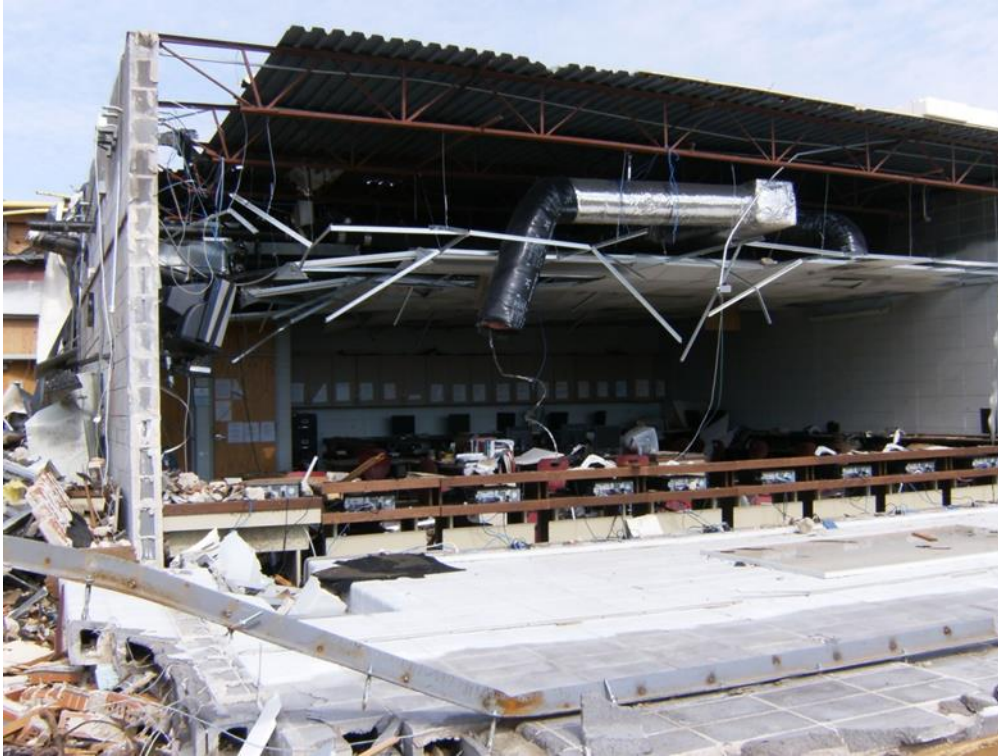
Figure 3-72. Collapse of CMU wall due to loss of lateral roof bracing.

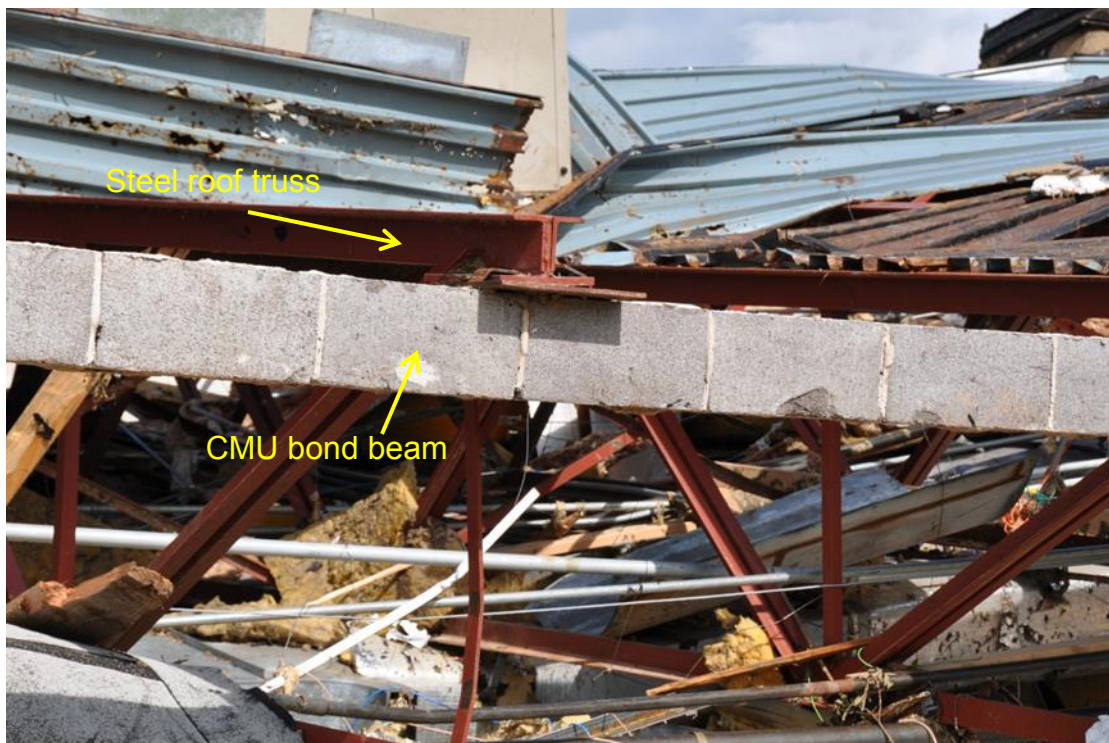
Figure 3–76. Steel roof deck and roof joist connection to CMU wall bond beam.

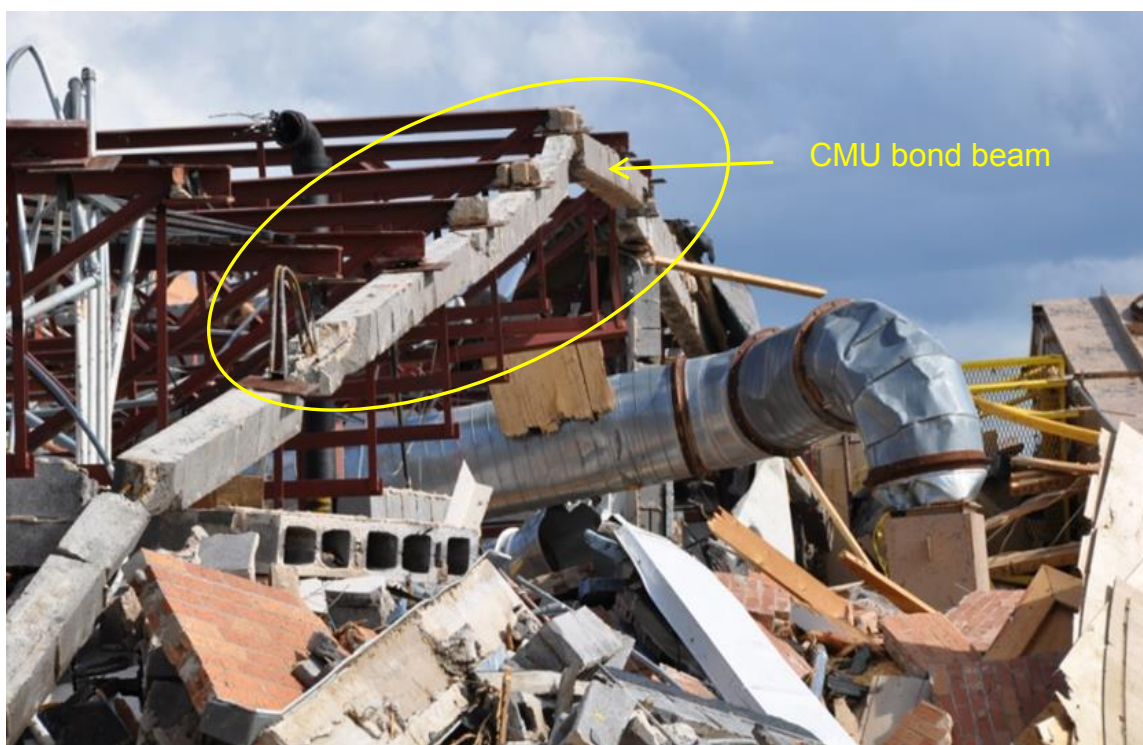
Figure 3–77. Steel roof joists, with missing roof decks, remained connected to CMU bond beam. Bond beam remained continuous, but was disconnected from the CMU walls along the bond line between the two CMU courses at the top of the wall.

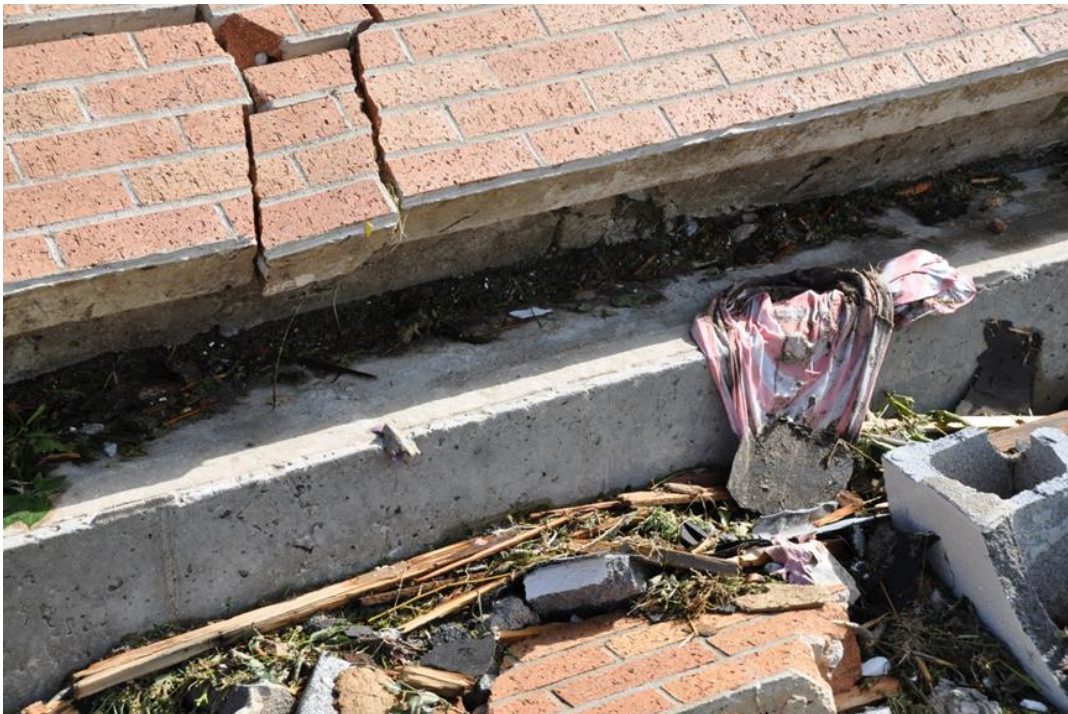
Figure 3-79. Perimeter CMU wall that collapsed after loss of roof lateral bracing (note lack of reinforcing dowels connecting wall to concrete footing).

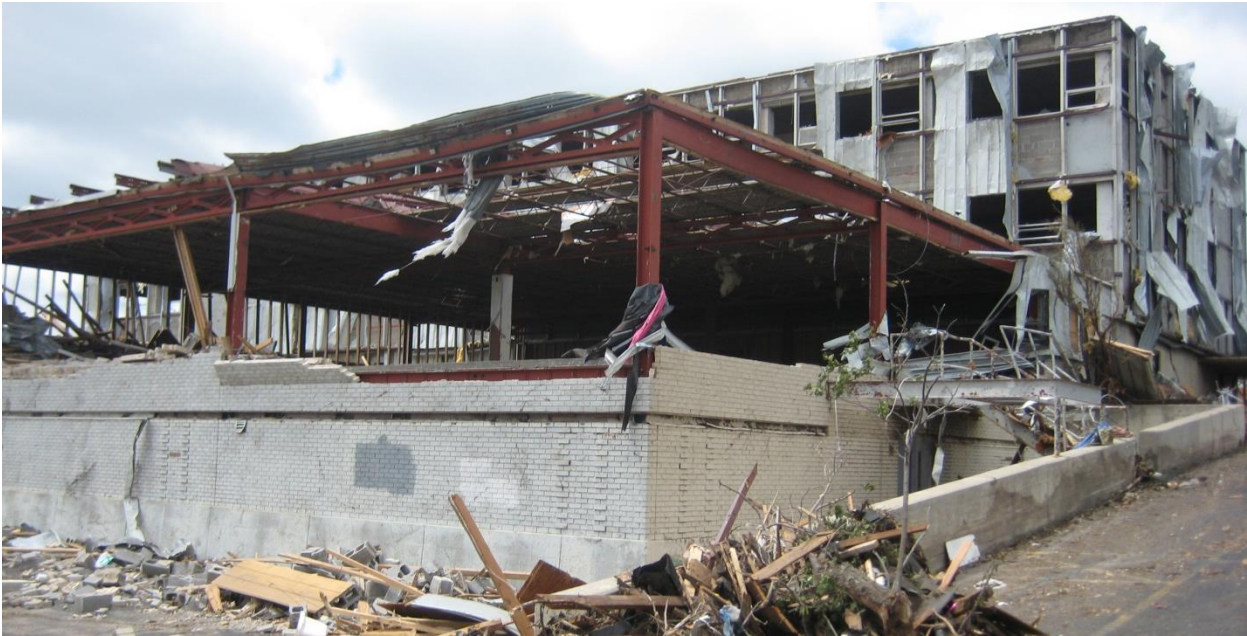
Figure 3–88. Significant damage to the envelope and minor damage to the MWFRS of the physical education section of the Ozark Center building, including (1) loss of part of steel roof decks, (2) loss of all insulating windows and steel frames on all wind-exposed sides, and (3) deformation of steel beam (likely due to debris impact).

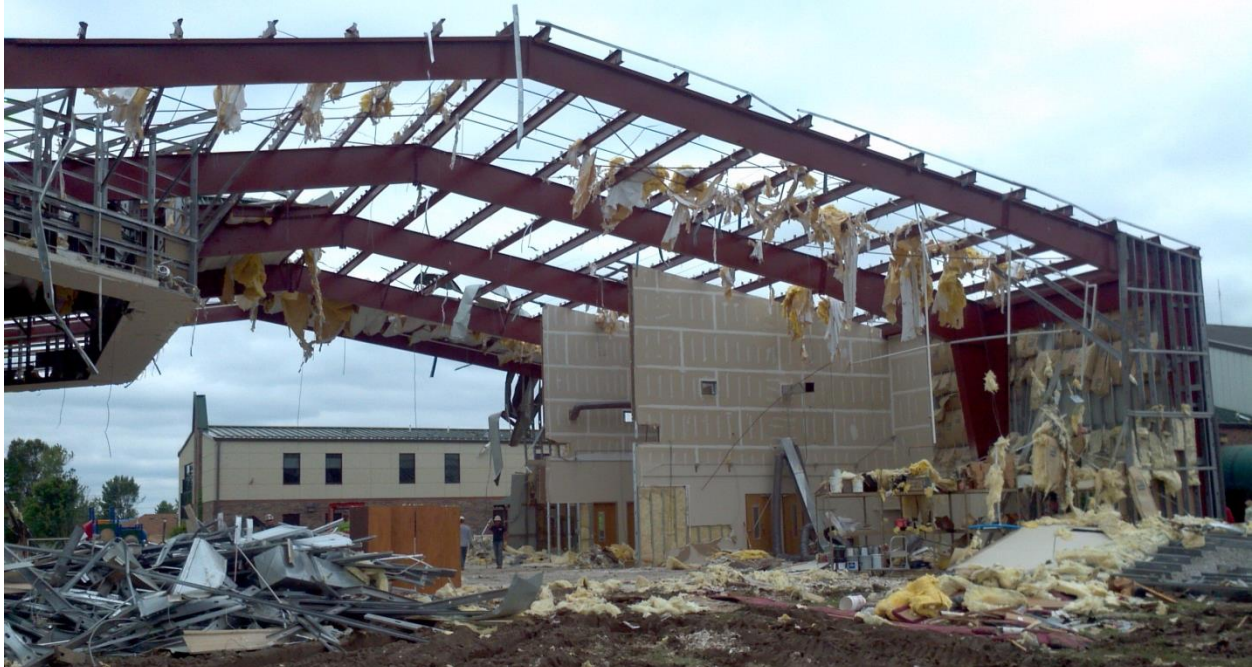
Figure 3–92. View from east of the damaged, pre–engineered steel Mass Hall building of St. Paul’s United Methodist Church.

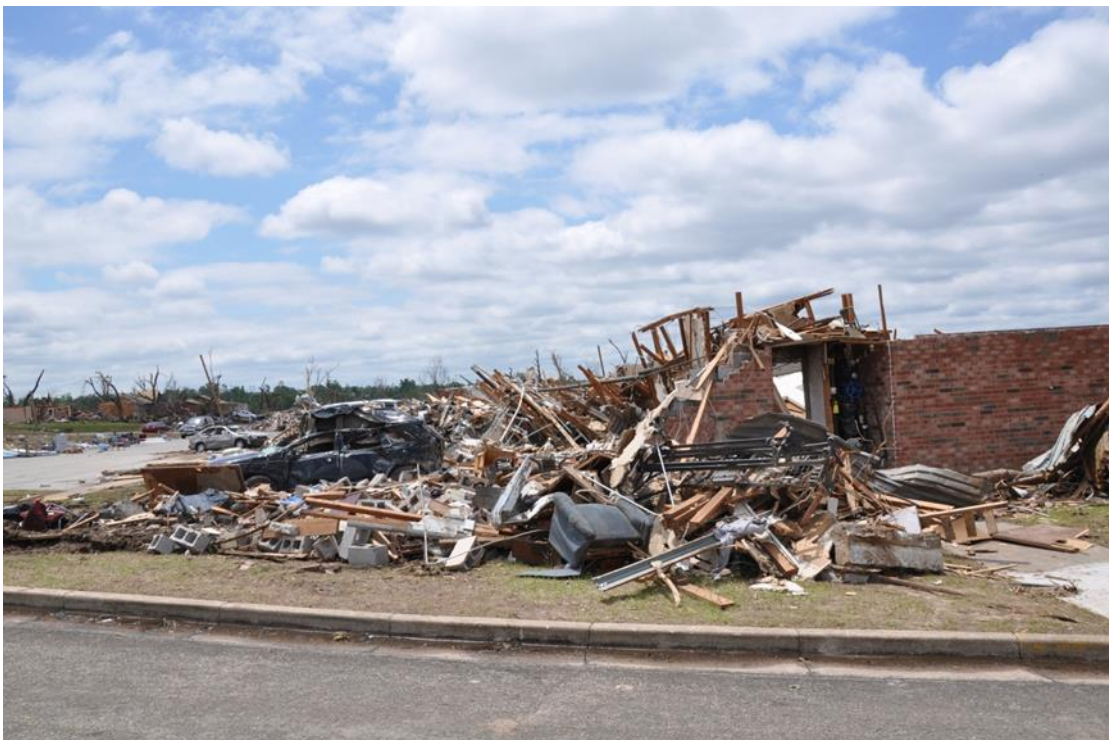
Figure 3–106. Collapsed Greenbriar Nursing Home (viewed from the north) showing the portion of the north wing's exterior wall that did not collapse.

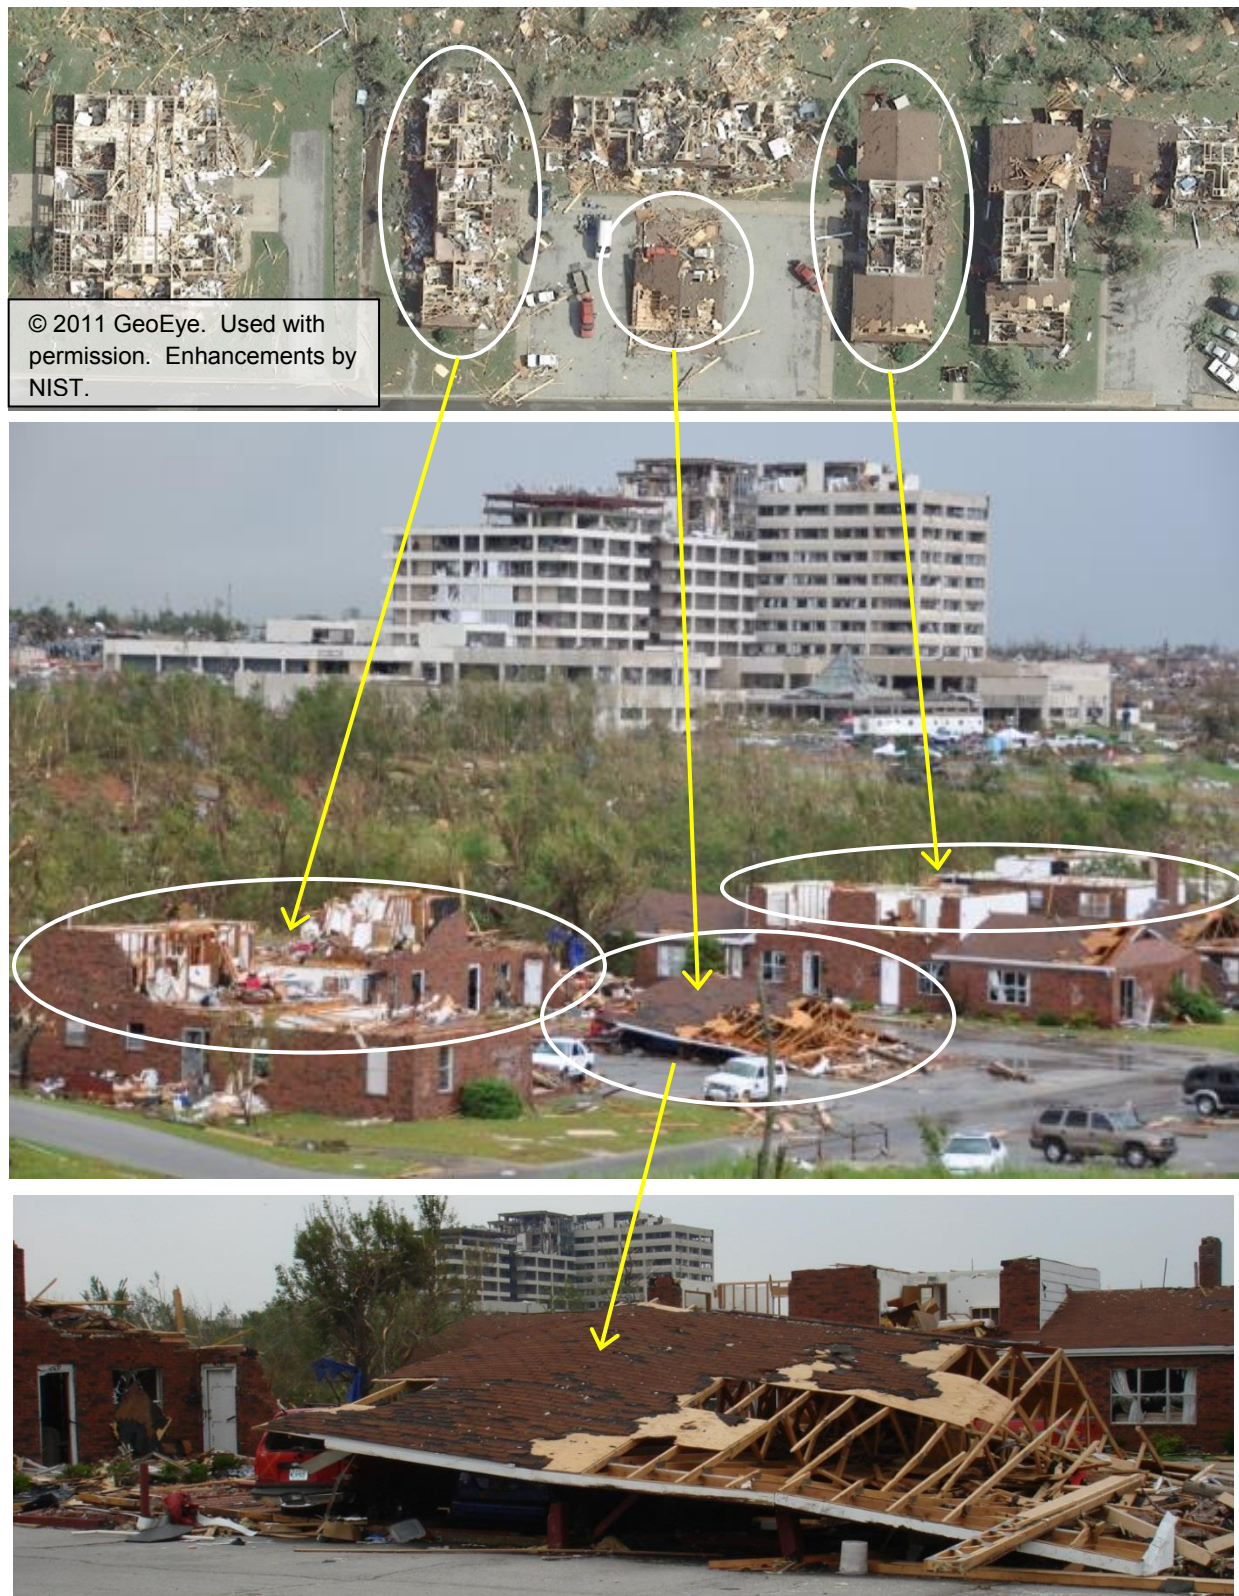
Figure 3–113. Residential failure due to disconnection of entire roof system (roof-to-wall connection failure due to wind uplift).

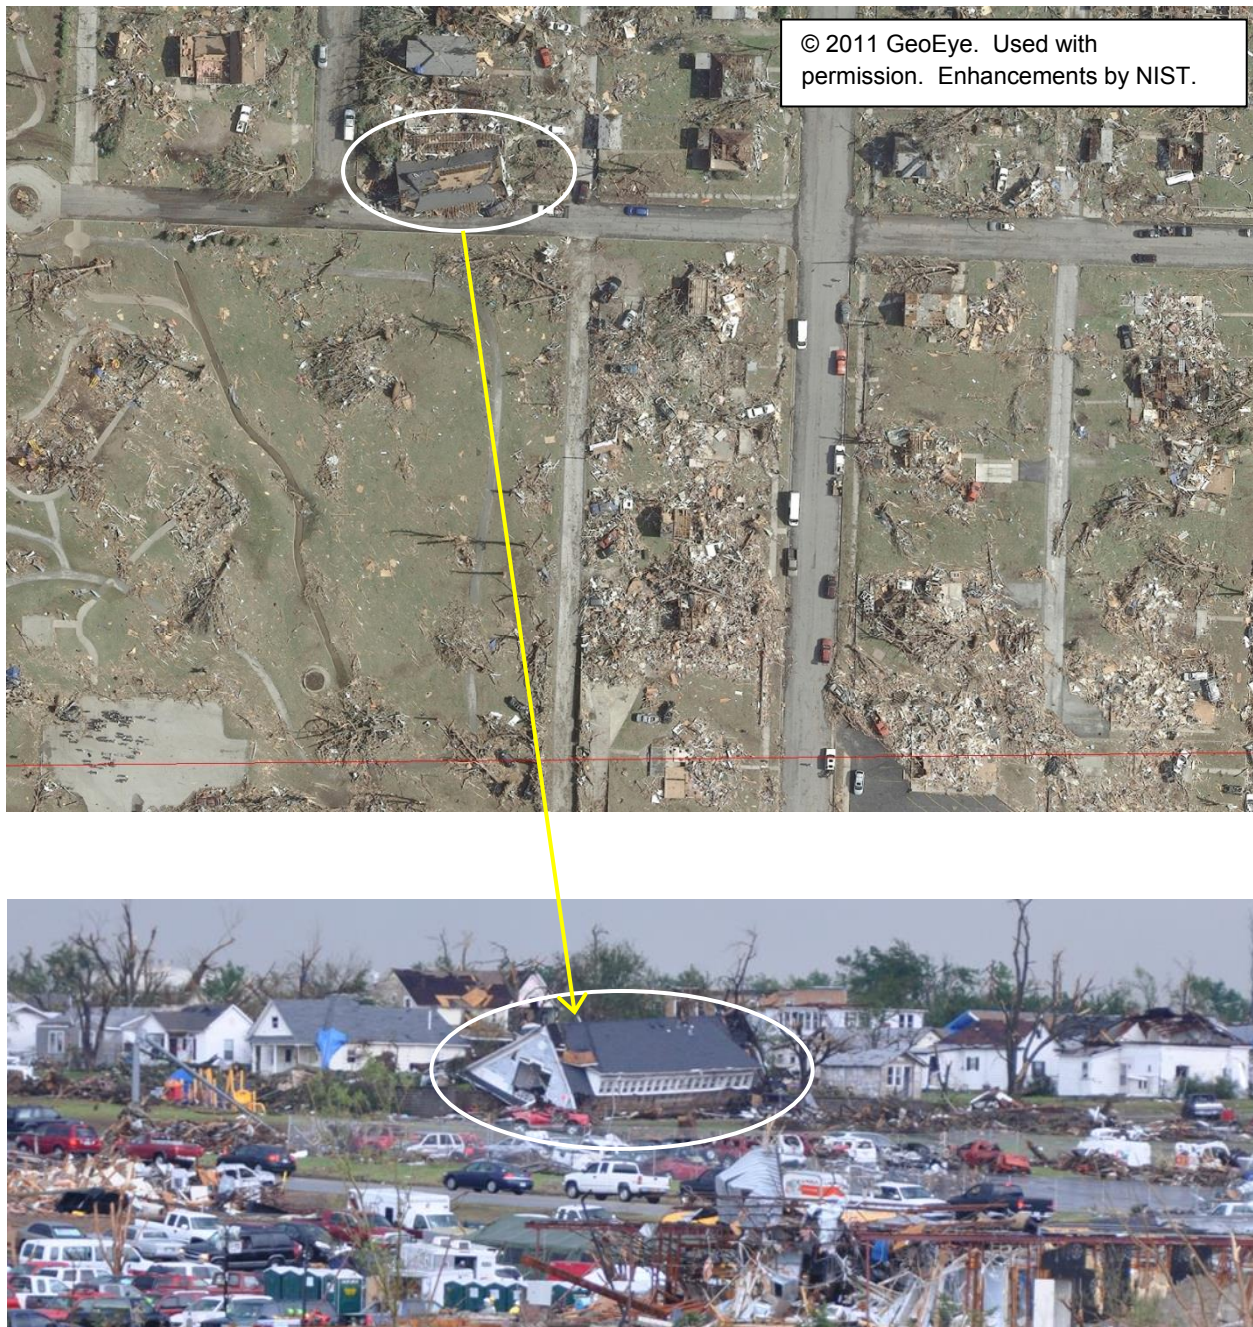
Figure 3–114. Failure of first-story-to-foundation wall connection. Entire roof and first floor shifted off of lower story (directly north of SJRMC).
